URBAN FORESTRY ASSOCIATES, INC.

ARBORIST REPORT

The Meadow Club- 1001 Bolinas Road, Fairfax, CA 94930

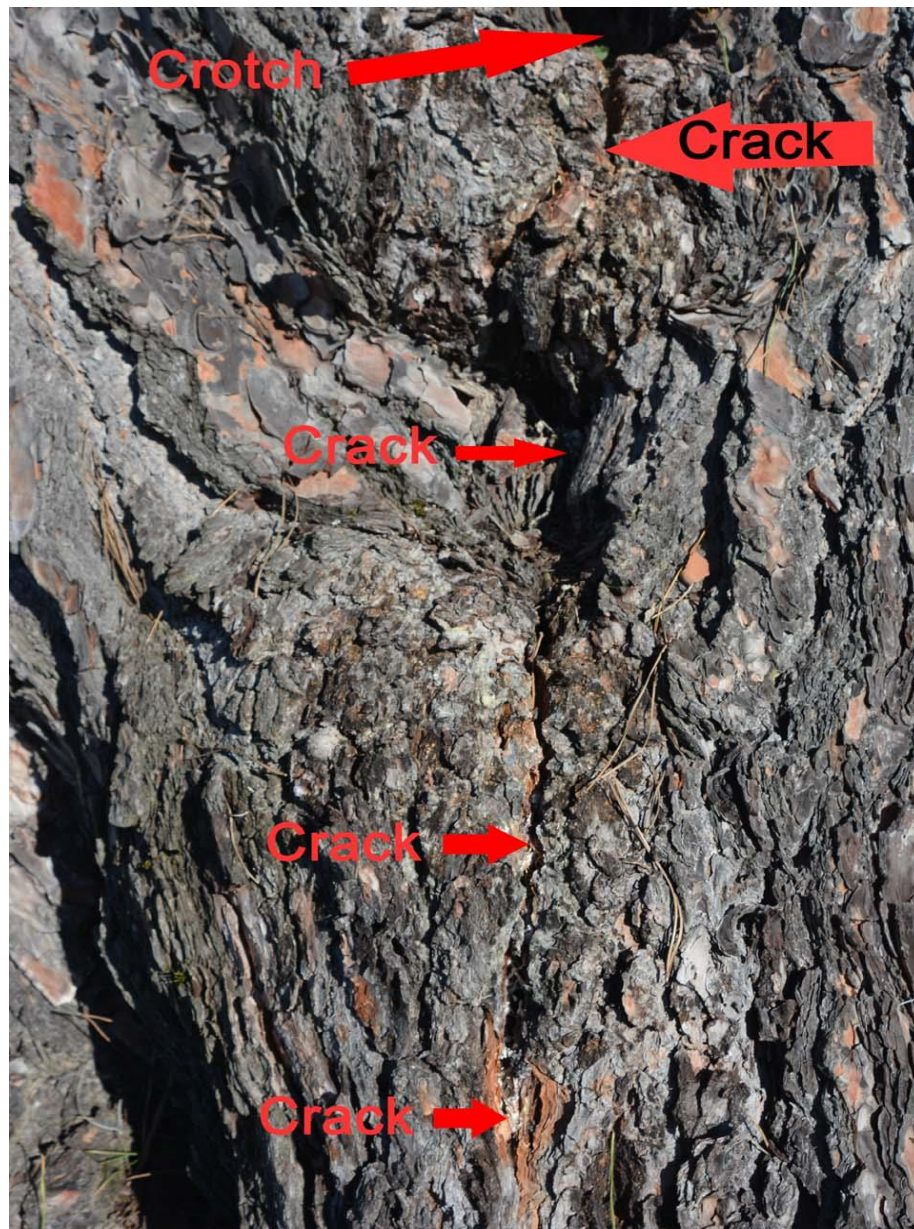
2019 Condition: Overall fair health but hazardous structural condition. Our inspection found that a deep crack had formed in the southwest side of the main crotch and butt section down to the soil line (See Figure 1). One cable has broken, one has loosened, while the third cable has tightened (See Figure 2).

2019 Conclusions: The widening of the main crotch gap and the crack indicates the failure of the main crotch. The loosening of the failure of one cable, the loosening of a second cable, and the tightening of the third cable indicates that the northeast trunk and canopy is twisting. The fact that the crack first appeared on the SW side of the butt also supports torque failure. The only thing preventing total failure is the one remaining cable and given the failure of one cable, that support is highly questionable. The failure or removal of the NE trunk and canopy will further destabilize the southwest trunk and canopy. Therefore the entire tree should be removed in a single operation. No permit is required because the Stone Pine is not a County "protected tree". **This tree is an imminent risk to people.**

Figure 1: Fracture crack extending down from main crotch to the butt section base.

Recommendation: Remove the entire tree as soon as possible.

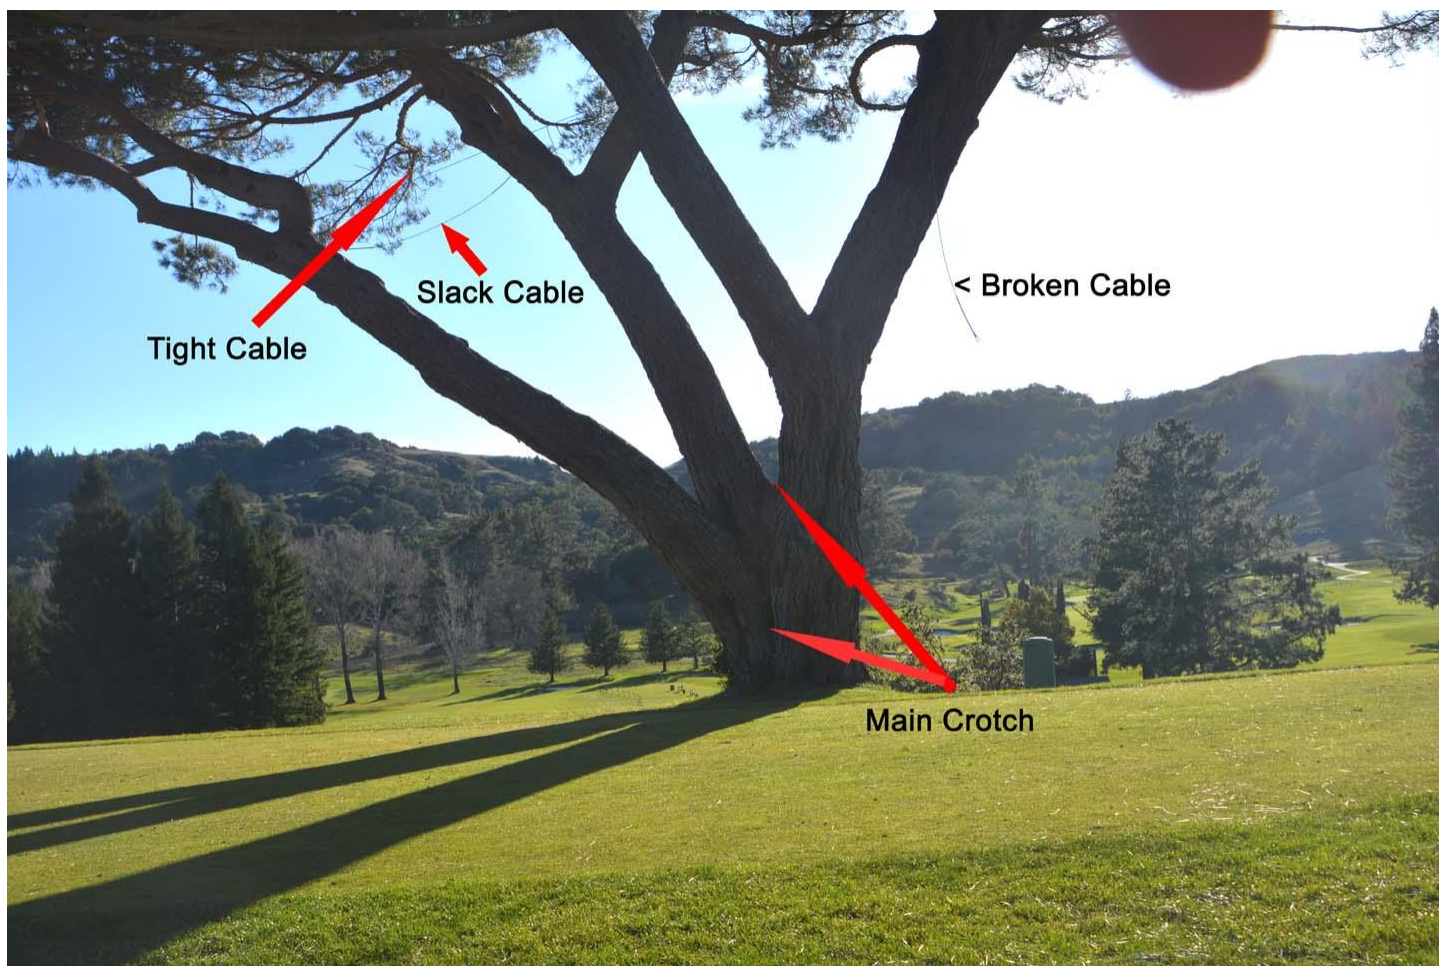
Figure 2 – The northeast trunk and canopy is twisting and failing toward the #1 Tee. It is a high risk of failure
